DEFECTS IN HARDWOOD VENEER LOGS: Their Frequency and Importance

E. S. Harrar

SOUTHEASTERN FOREST
EXPERIMENT STATION
Asheville, North Carolina

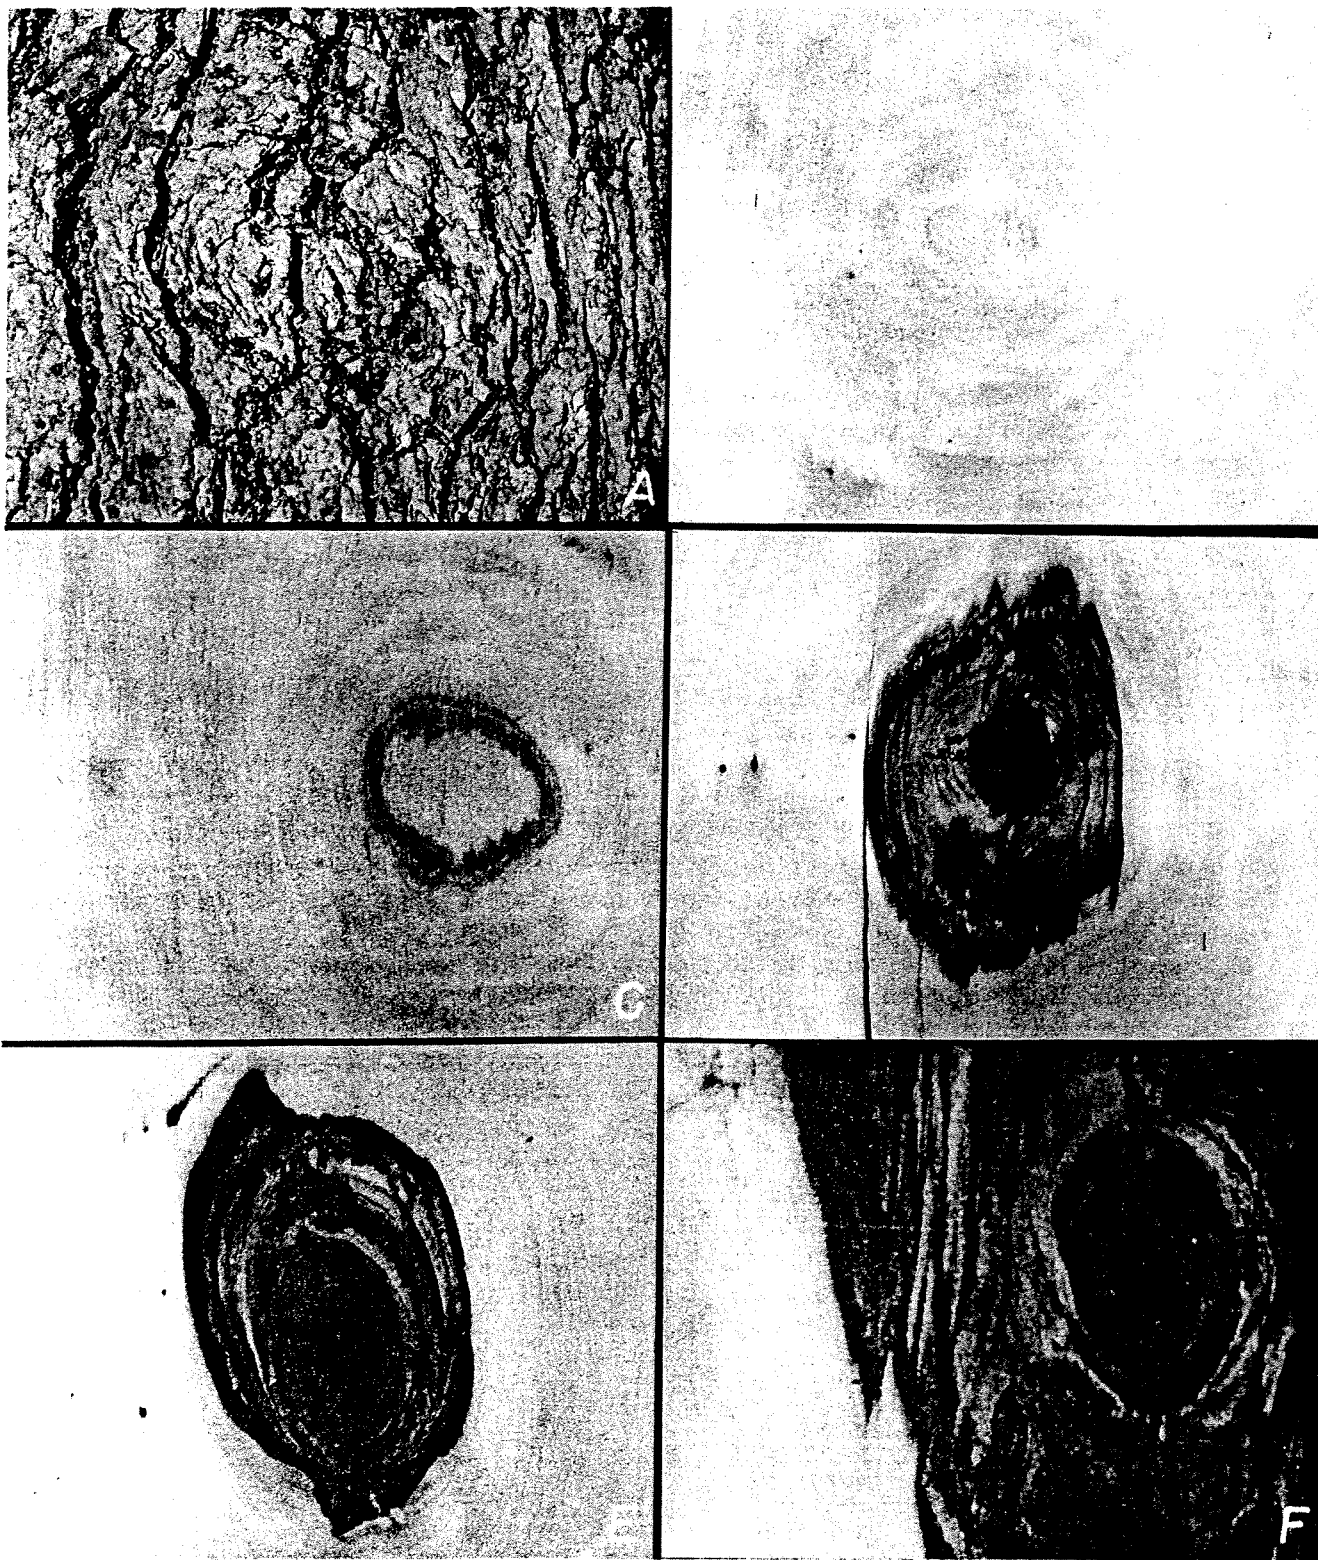
Overgrowths in sweetgum.---One of the most common types of overgrowth in second-growth sweetgum logs of small diameter is the "cat's eye." This is a slightly depressed bark distortion indicative of the presence of a buried branch immediately below (fig. 20). The distortions on larger logs or where the stub is more deeply buried are quite similar to those of yellow-poplar. Obliteration of overgrowths on sweetgum appears to take much longer than in yellow-poplar.

Figure 20.--Cat's eye and defect in underlying veneer from sweetgum block. Cat's eyes are usually slightly depressed.

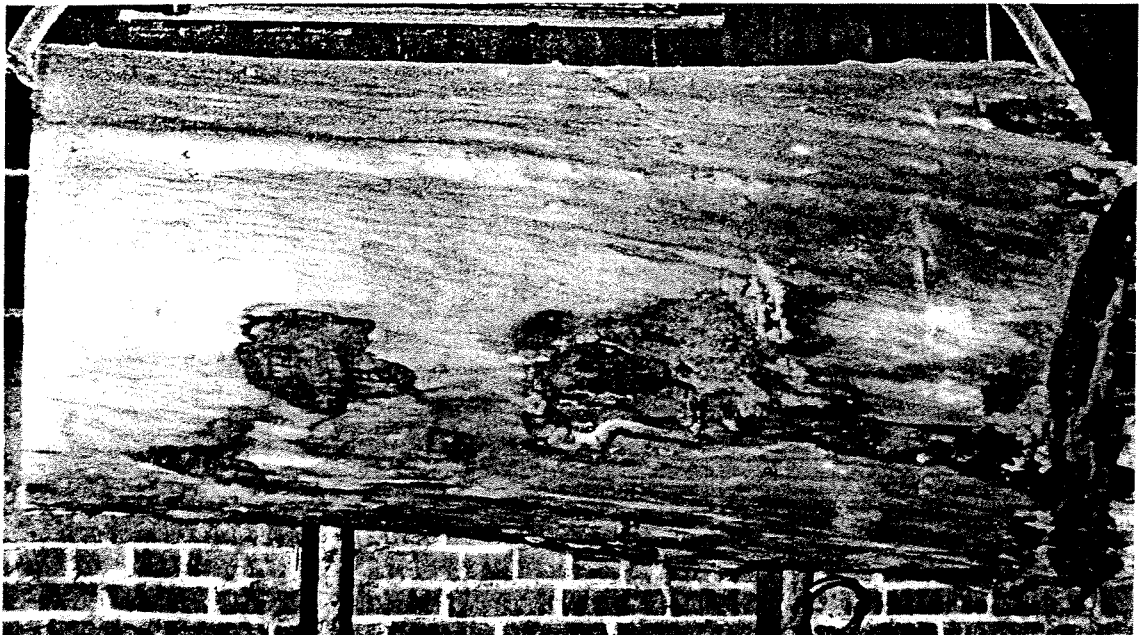
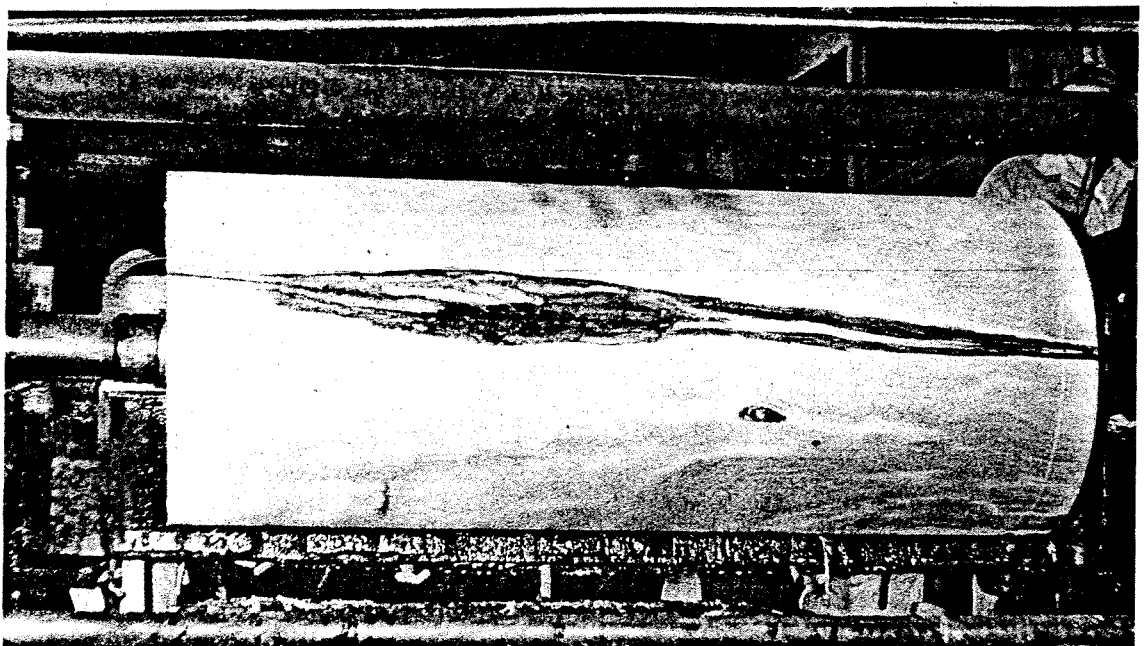
Figure 21.--Seam in sweetgum block. Note streak of decay below seam.

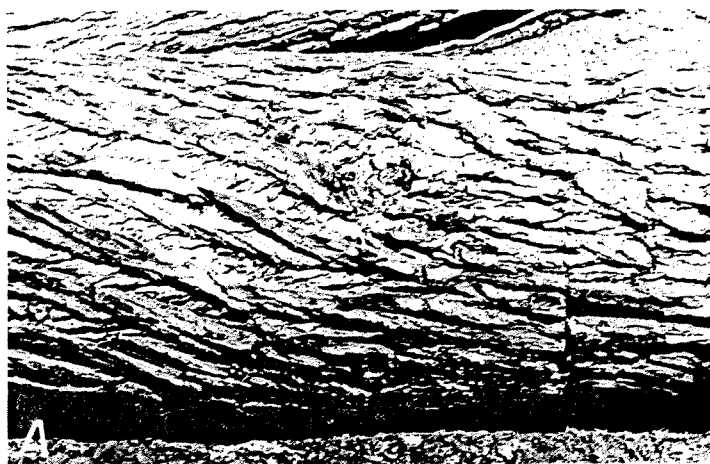
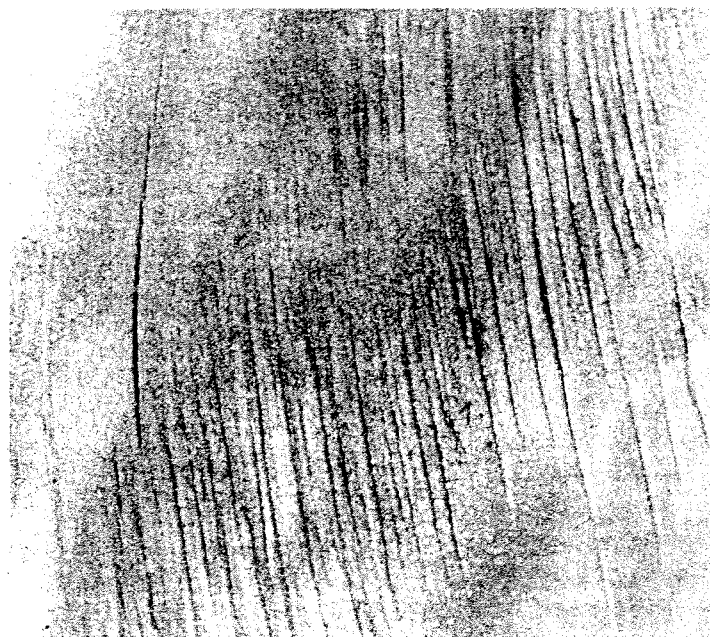
this latter condition. Spiral bark does not connote defect in the usual sense, but its presence on sweetgum logs (fig. 22) invariably indicates wood of inferior quality and limited utility. Logs with spiral grain produce veneers with rough, uneven surfaces that shrink and warp excessively in drying. In the development of any set of log grades involving sweetgum, the degrading effect of spiral bark must be considered, even when such logs are otherwise free from external indicators of defect.

Figure 22.--A, Spiral bark in sweetgum.
B, Rough cut veneer from spiral-bark log.

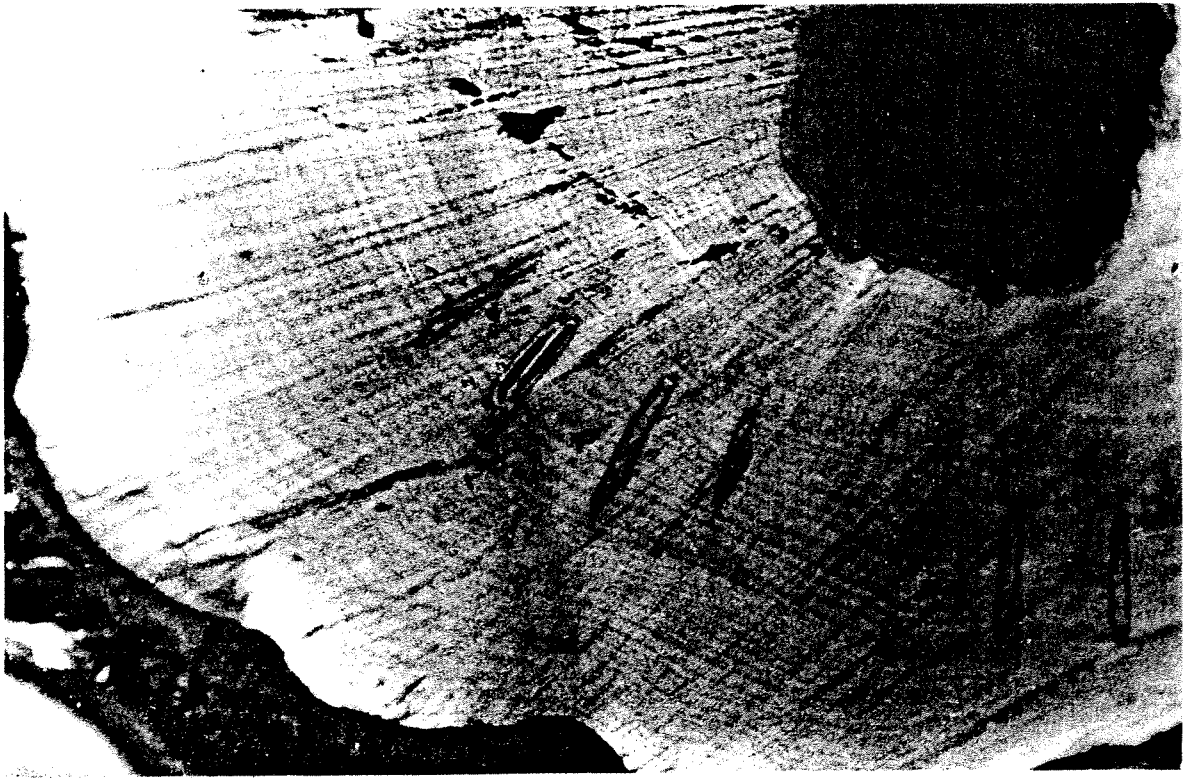
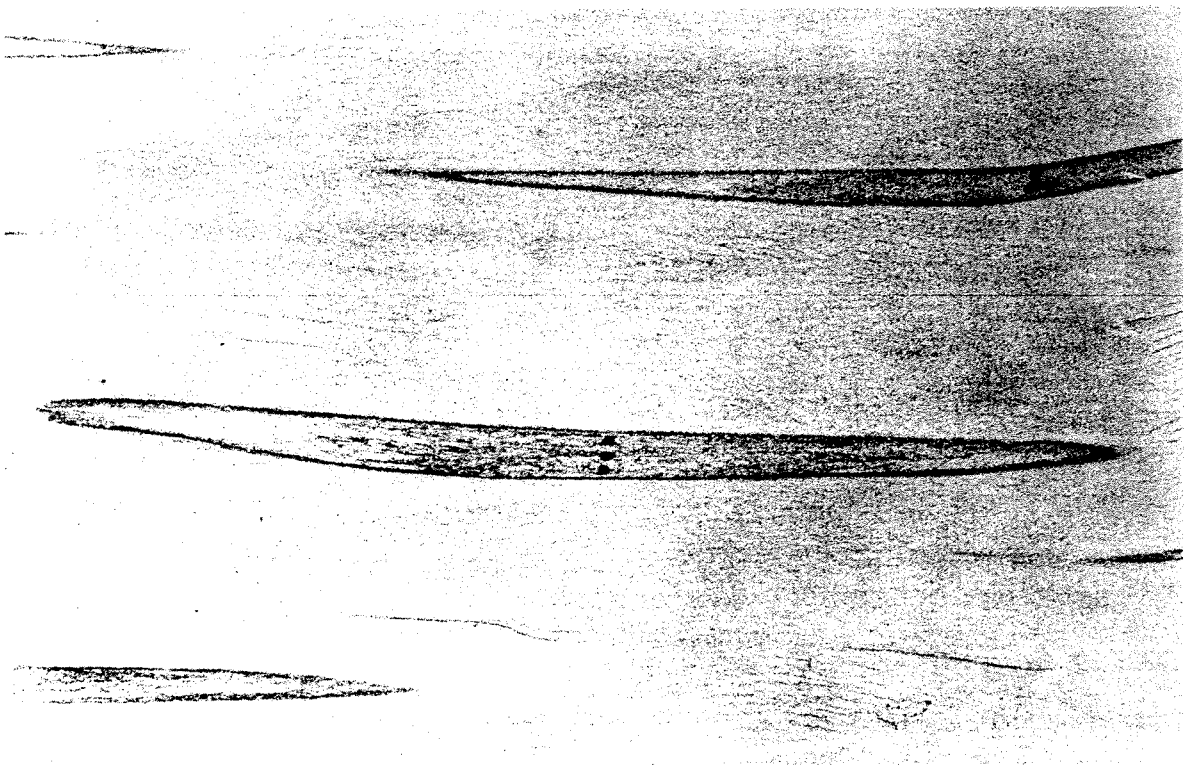
Figure 23.--A, Flag worm in sweetgum. B, Flag worm injury in veneer, with holes caused by Columbian timber beetle.

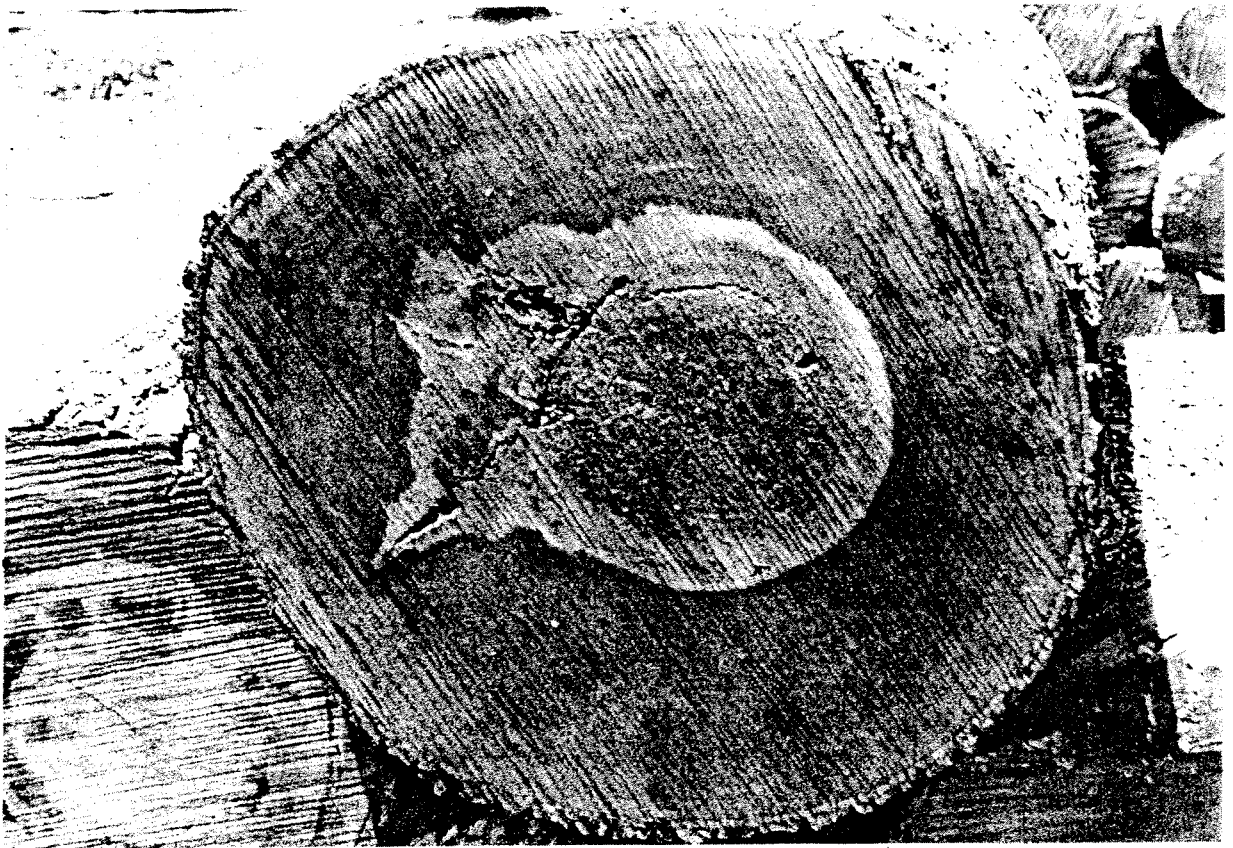
Figure 24.--Heart rot in yellow-poplar.

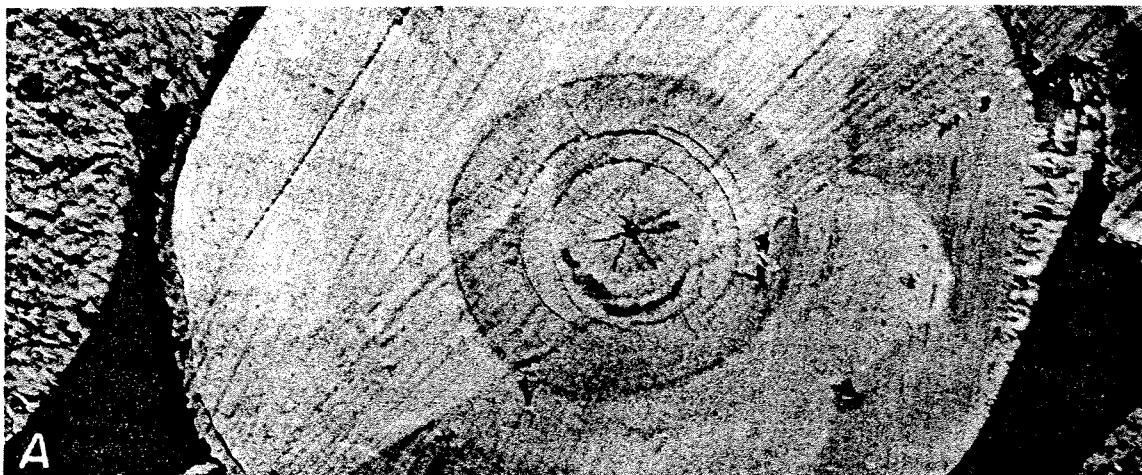
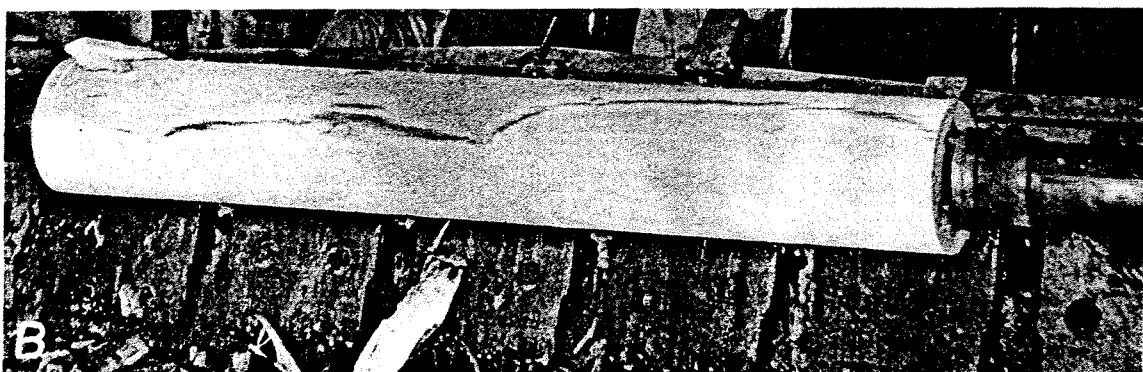
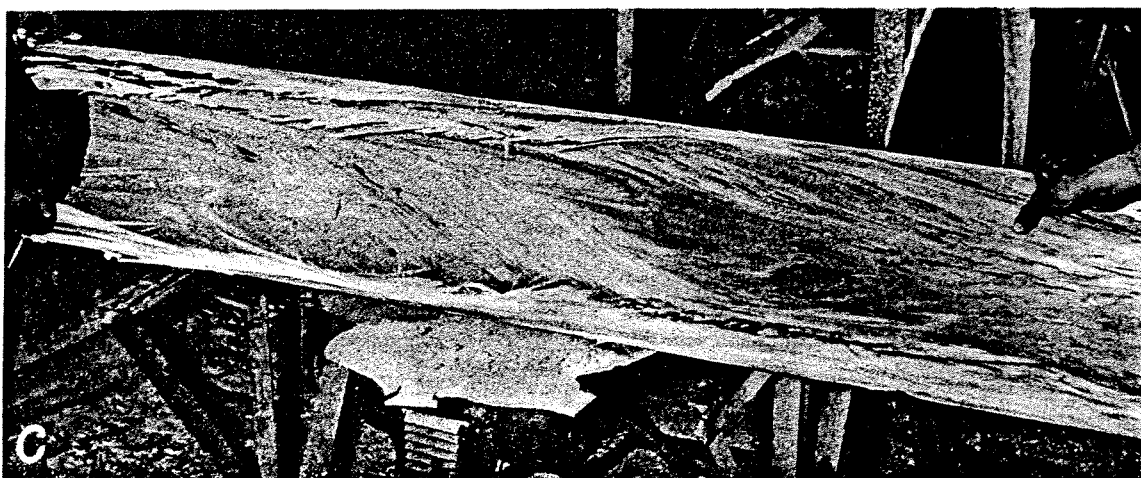
In effect, a log with loose heart comprises an inner cylinder of wood surrounded by a more or less detached outer layer (fig. 25). This, coupled with the fact that wood from the vicinity of loose heart is usually soft, brash, and below average density for that of the species, makes the turning of such logs difficult. Chucks cannot be firmly seated in soft, brashy wood,

and a block will "hang up" on the nose bar and knife; meanwhile if the chucks continue to turn, the heart center becomes free and further peeling is impossible. The use of larger chucks will often prevent this difficulty, but in any case the residual core is large and veneer yield small. Eccentric chucking of such blocks in a lathe permits a degree of salvage, but here again large cores are inevitable and veneer recovery is incomplete. When the central core about loose heart is particularly brash and weak, the revolving block may suddenly split open and break out of the lathe before peeling is completed, in which case it is rendered completely worthless for further production of veneer. Finally, if the loose-heart zone is large and the chucks fall inside of the loosened area, peeling is impossible.

Figure 25.--Loose heart in tupelo and its effect on the cutting of rotary veneer. In photo C the veneer core separated from rest of bolt when knife entered loose heart zone.

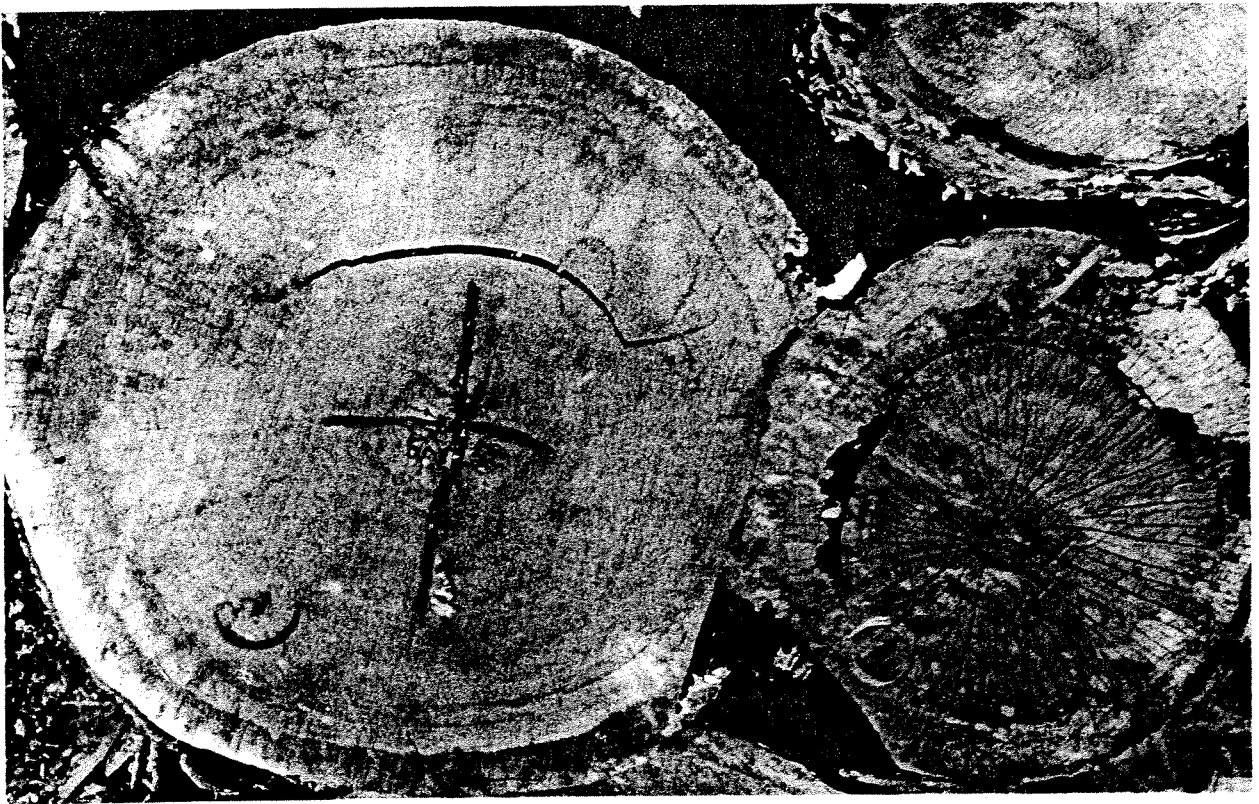
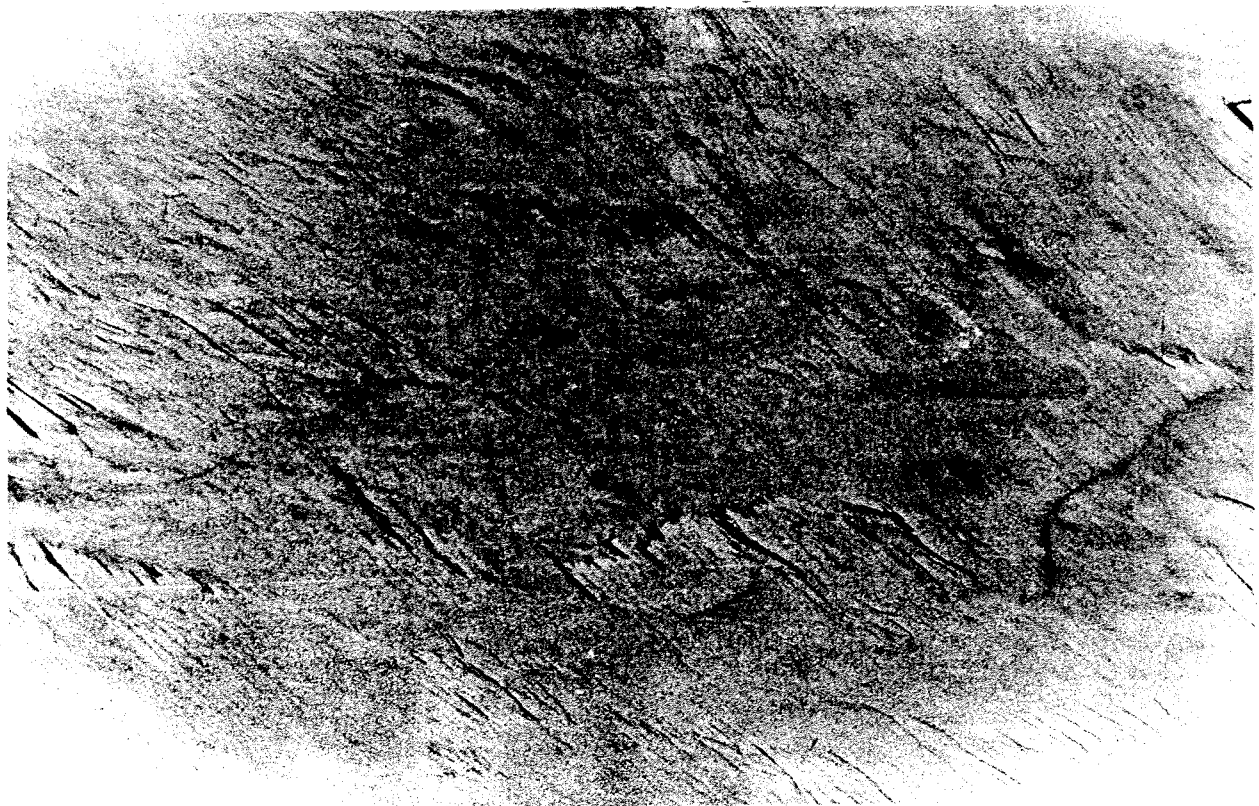
Figure 26.--Ring shake in tupelo log ends and in the veneer.

Among the four species under observation, ring shake was most prevalent in tupelo. Veneer cut from such material is often overly rough. The length of thin sheets is limited to the possible number of turns between any two adjacent lines of rupture, while in thicker stocks sheet continuity is interrupted by (1) checks extending into the sheet for varying distances from either of its edges or (2) partial separations appearing in the form of oblique fissures extending well into and even through the sheet from face to face.

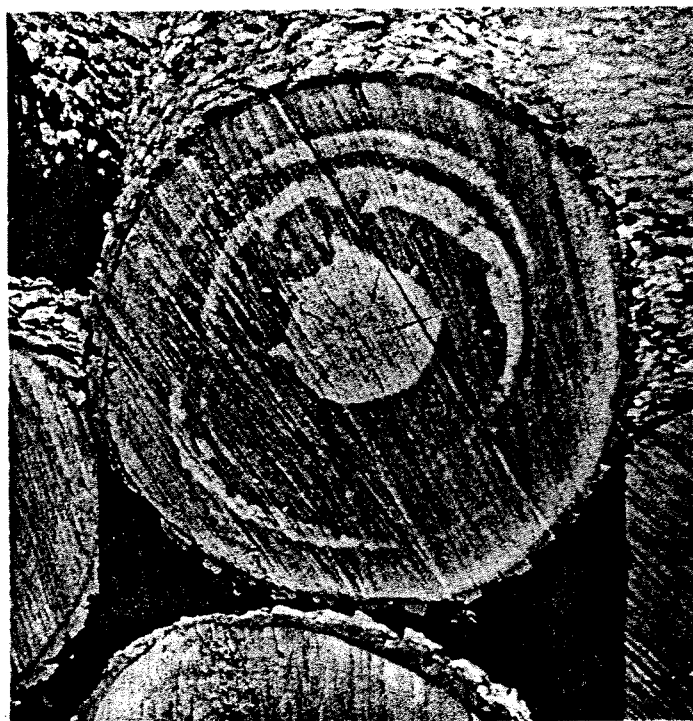
In veneer unselected for color, pathological heartwood is not objectionable and under normal circumstances cannot be regarded as a defect.

Figure 27.--Pathological heartwood in sweetgum.

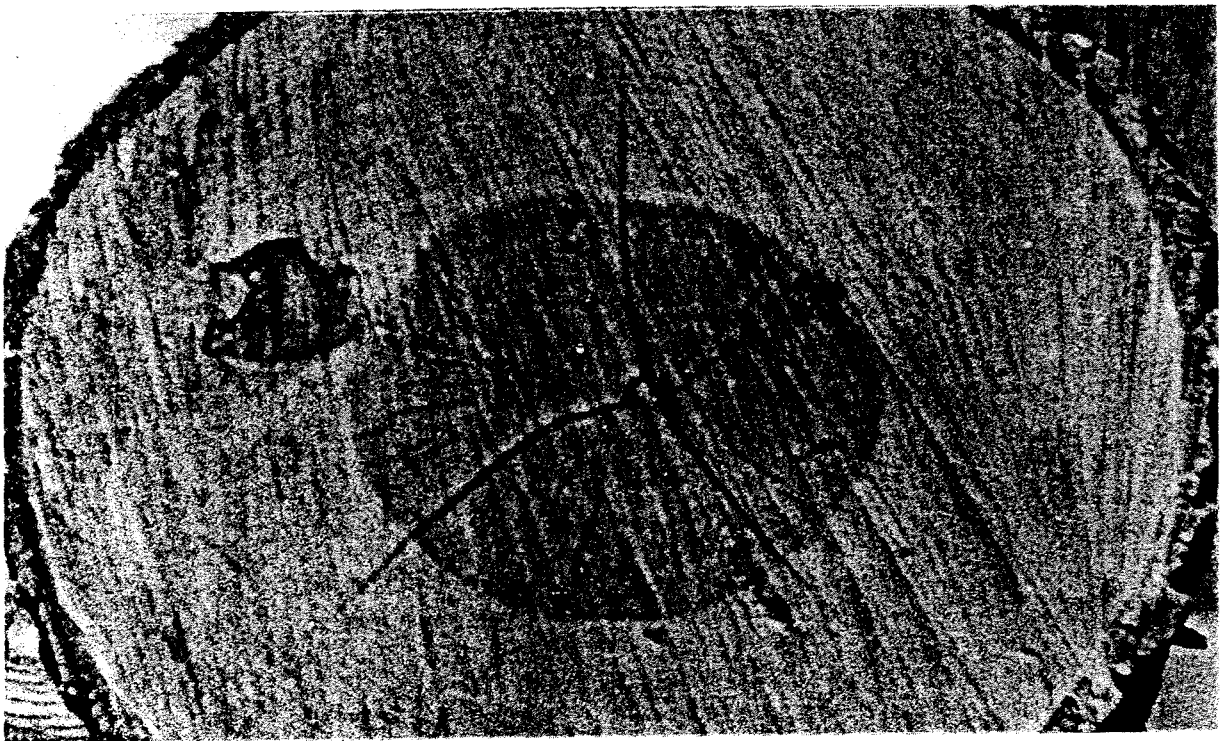
In veneer logs in which the lines of separation are poorly developed and fall wholly within the confines of residual cores, spider heart is not a defect. On the other hand, when one or more such lines of failure extend outward into the woody cylinder, long continuous sheets of veneer give way to the production of shorts. If only a single separation is encountered, sheet length is then equal to the circumference of the cylinder at the point where the knife crosses the break. Such sheets are suitable for panel production, but because of their variable lengths, clipping to a standard or

Figure 28.--Spider heart.

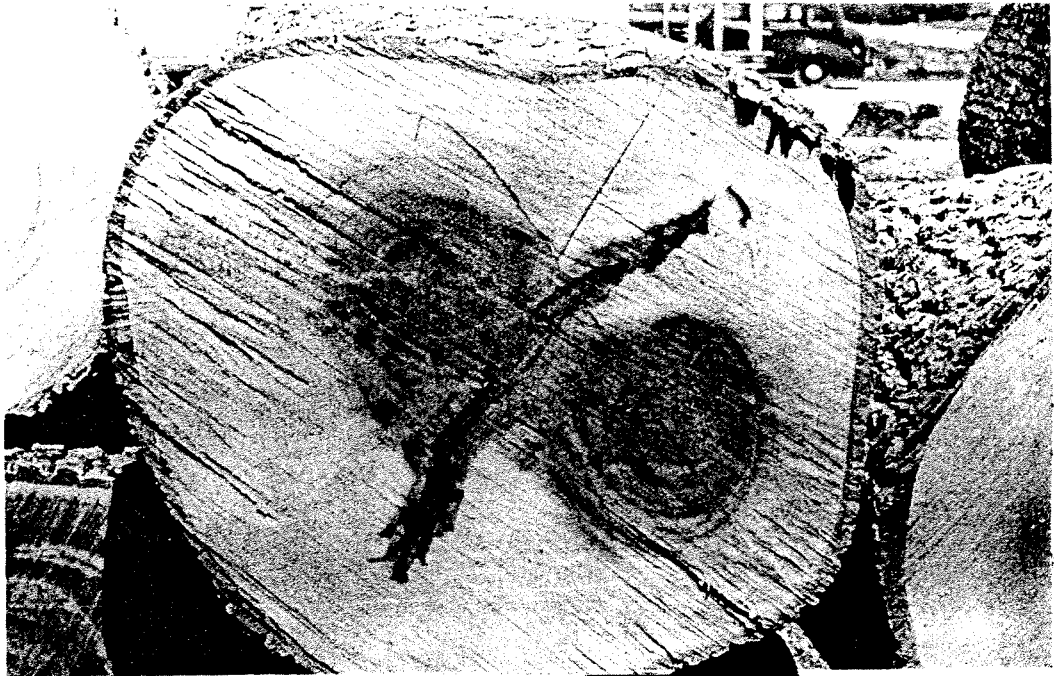
Figure 29.--Double pith in yellow-poplar.

Double pith must be classed as a defect in veneer logs, because the swollen edge, the included bark, and excessive grain distortion affect veneer quality and quantity. Diagonal and cross grain in such logs are prevalent, and veneer may be excessively rough. End splitting of the sheets is frequent. As the knife crosses the central bark pocket, sheet continuity is broken, and only shorts can be produced from the residual cylinder.

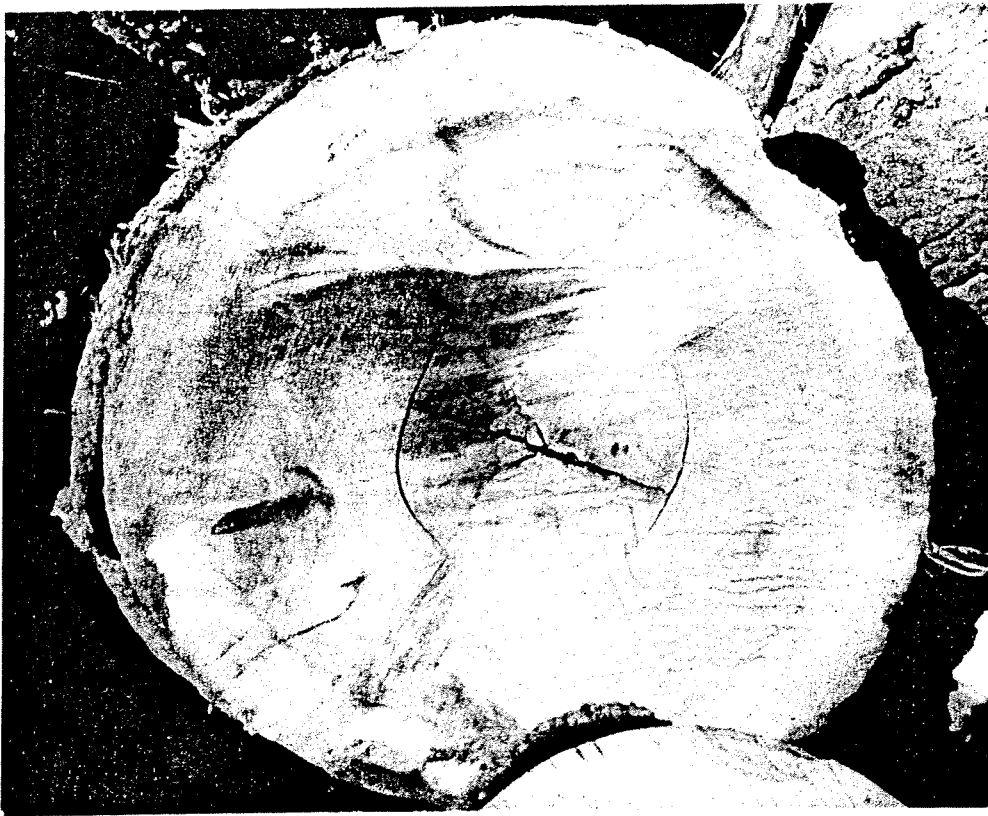
Figure 30.--Wind shake. Note also associated ring shake.

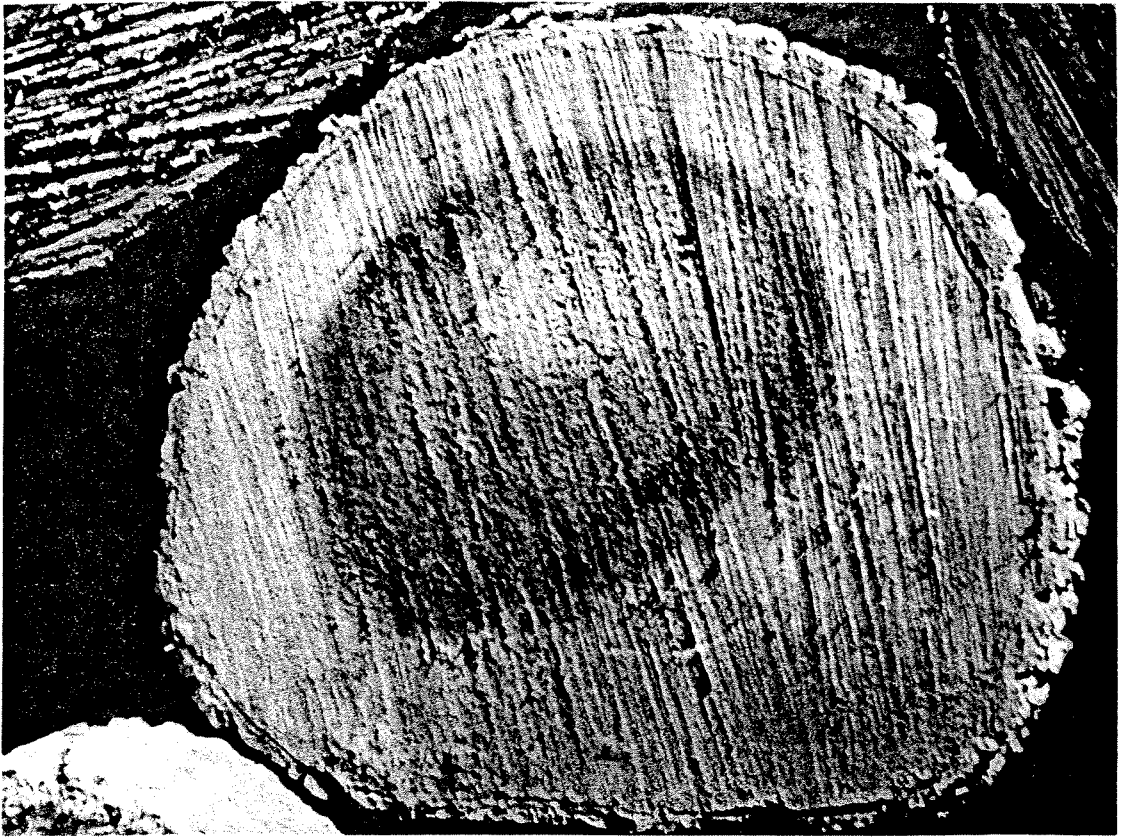
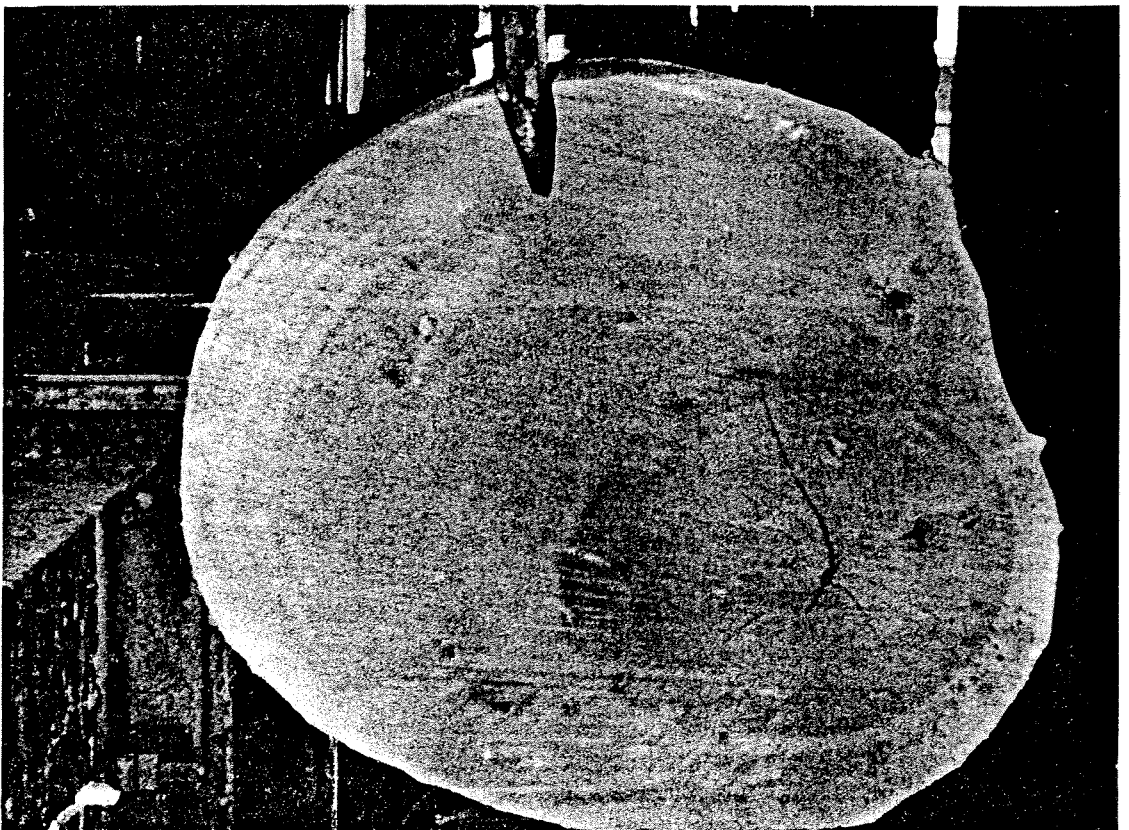
Many sound logs and blocks delivered to veneer plants are asymmetrical and feature flat sides, off-center piths or oval transverse sections (fig. 31). While such logs are frequently free from visible defect, they are less desirable for the production of rotary veneer than full-rounded stock. In the rounding, much clear peripheral wood goes into waste, and the salvageable shorts must be spliced to produce full-length sheets, thus adding to production costs. Allowance for waste should be made when grading and scaling such material.

Figure 31.--Out-of-round logs of yellow-poplar.
